Portage Creek Sediment Remediation Project Kalamazoo, Michigan

Post-Sediment Removal Structure Feature Assessment
Removal Areas SA1-A, SA1-B and SA1-C

F&V Project Number: 809930
October, 2013

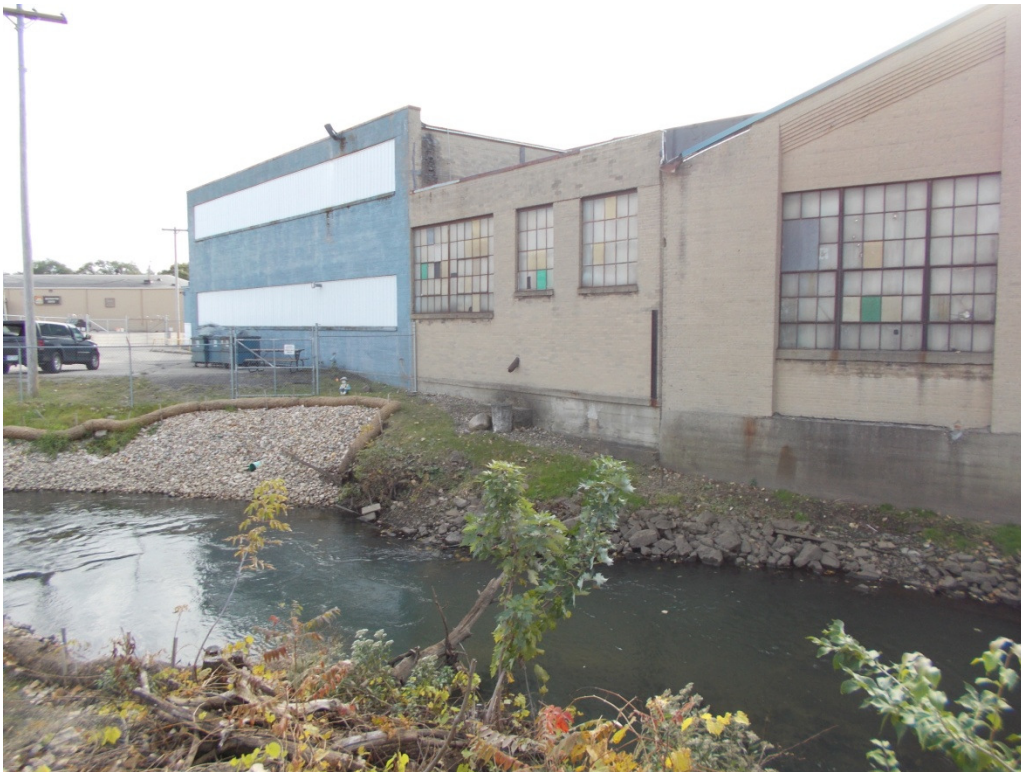
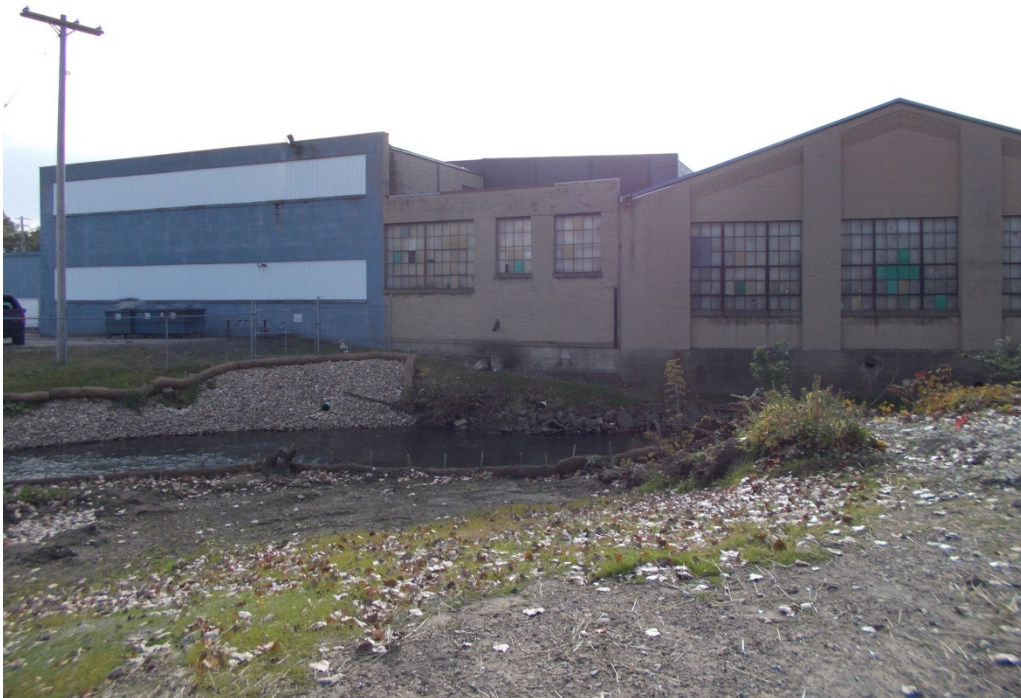
Structure: SA1-C-S01

- Cracking and undermining observed appears to be unchanged.
- The structure does not appear to have been impacted during sediment removal.

View of structure from northwest

Overall view of structure from the north

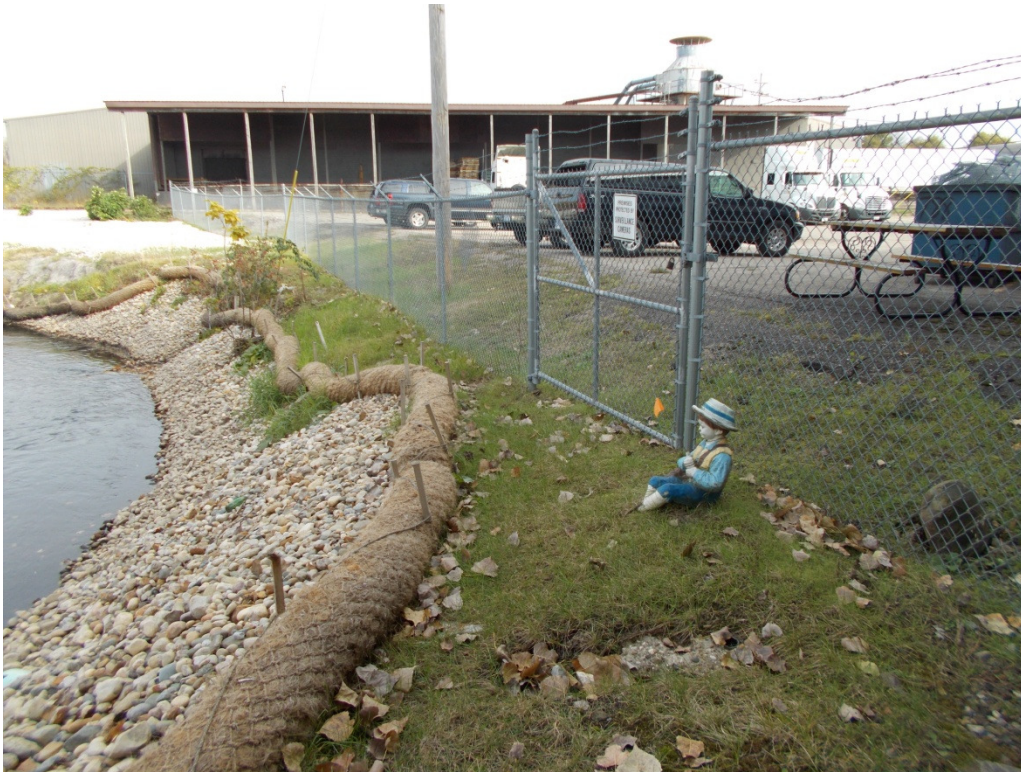
- The bank along the northern area of the fence has been restored with riprap.
- The structure does not appear to have been impacted during sediment removal.

View of fence looking north

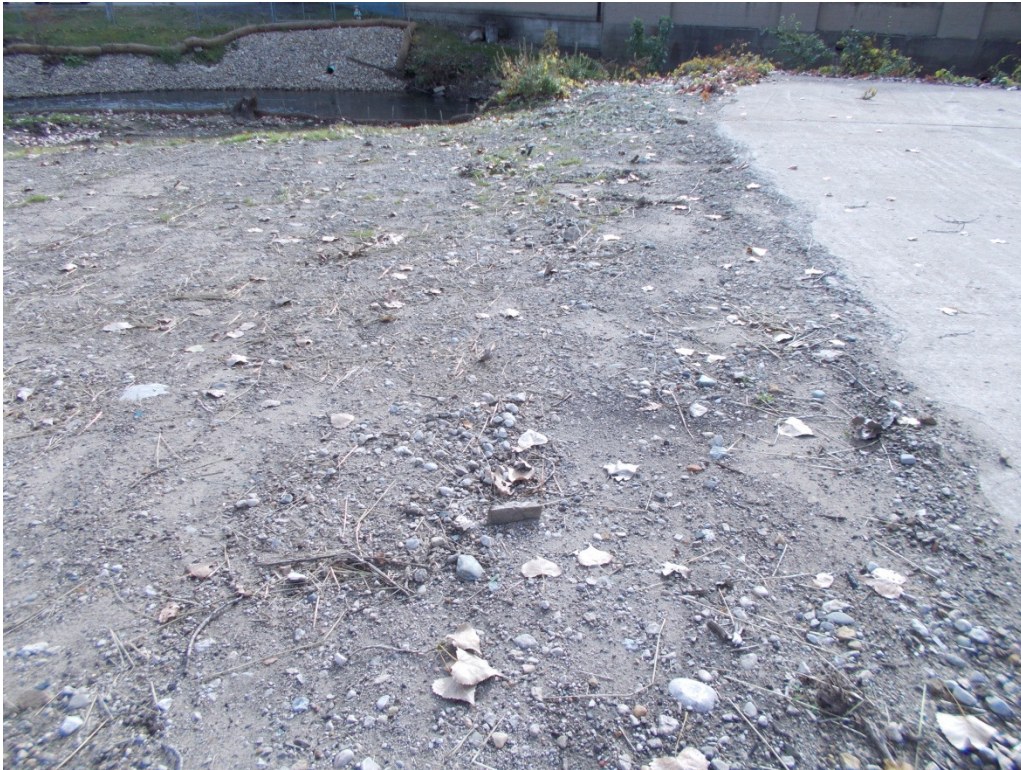
- The structure appears to have been removed during sediment removal operations.

View of previous location of SA1-C-S04

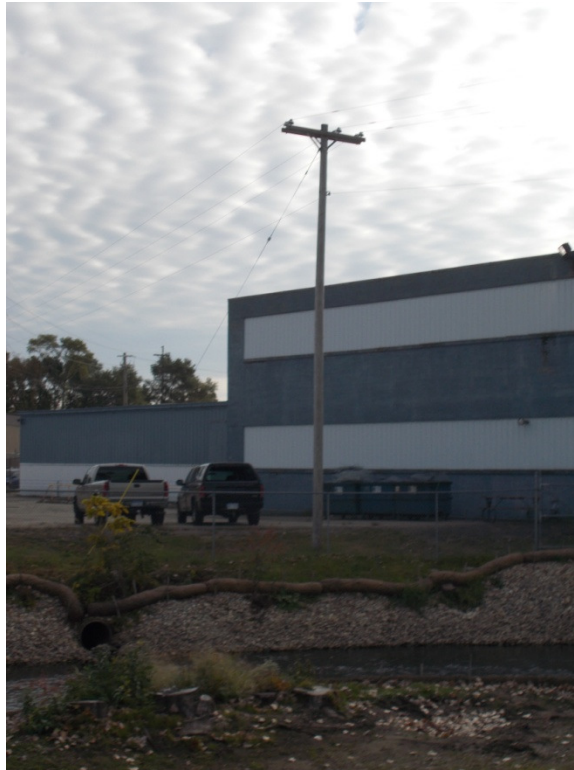
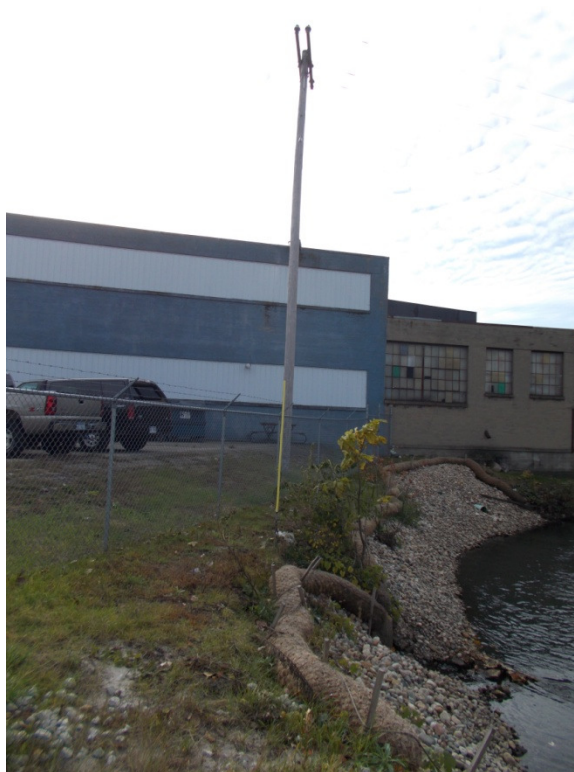
- The structure does not appear to have been impacted during sediment removal.

View of pole and guy looking southeast

View of pole and guy looking south

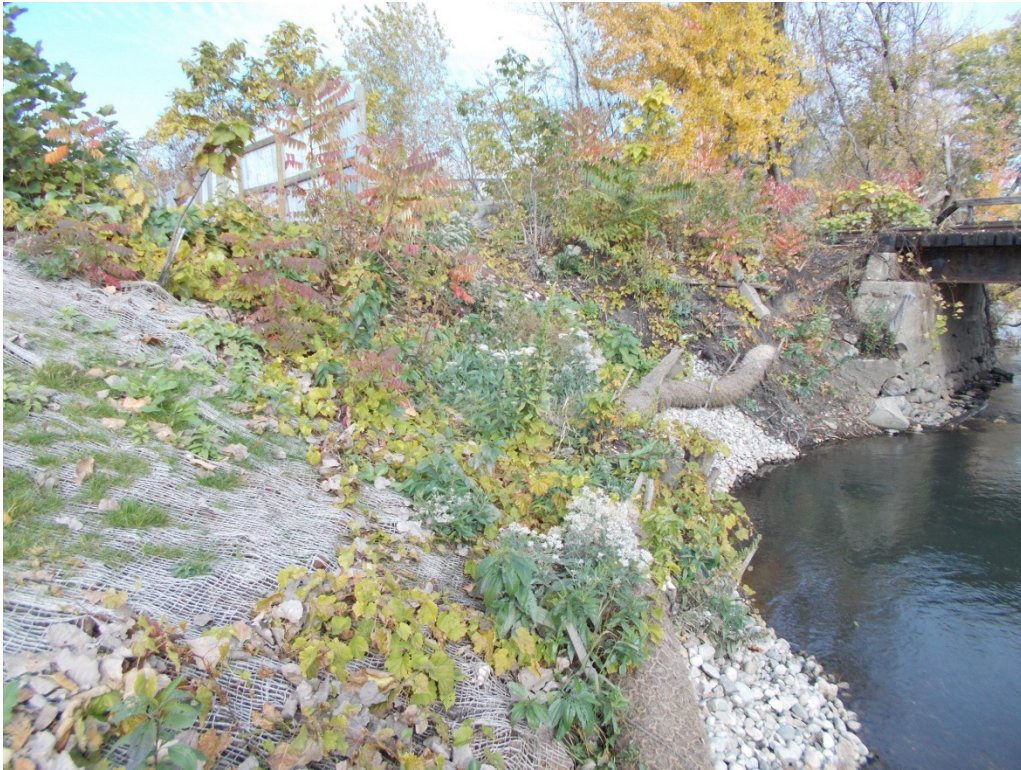
Designation: SA1-C-S07

- The structure has been removed.

View of previous location of SA1-C-S07

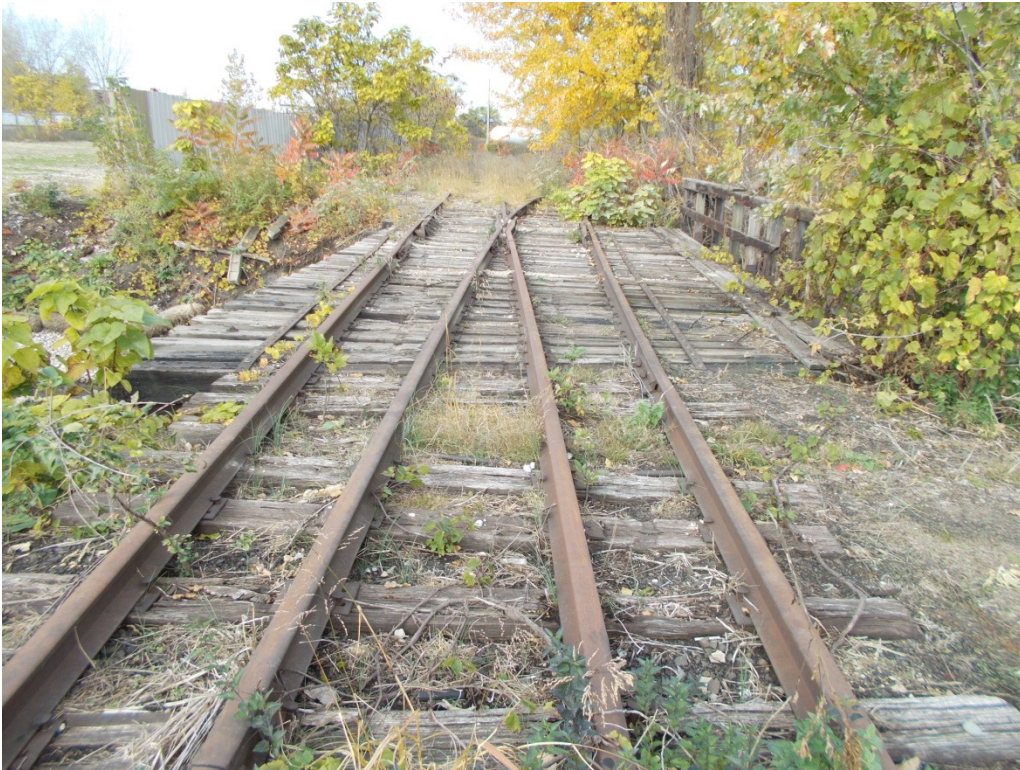
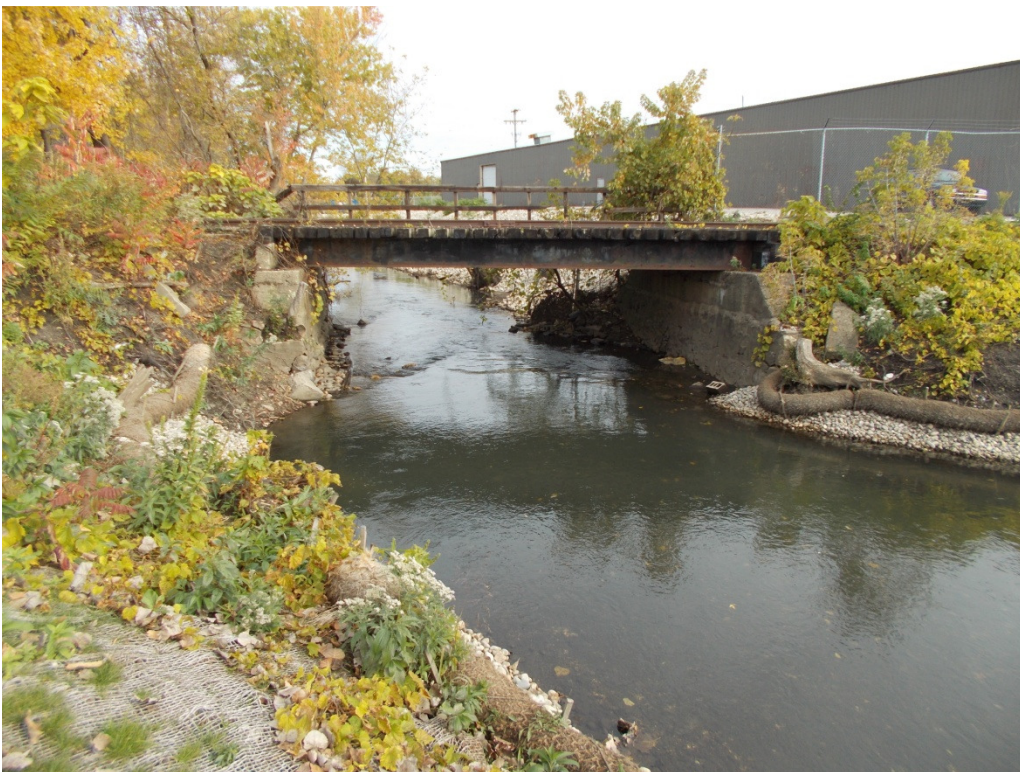
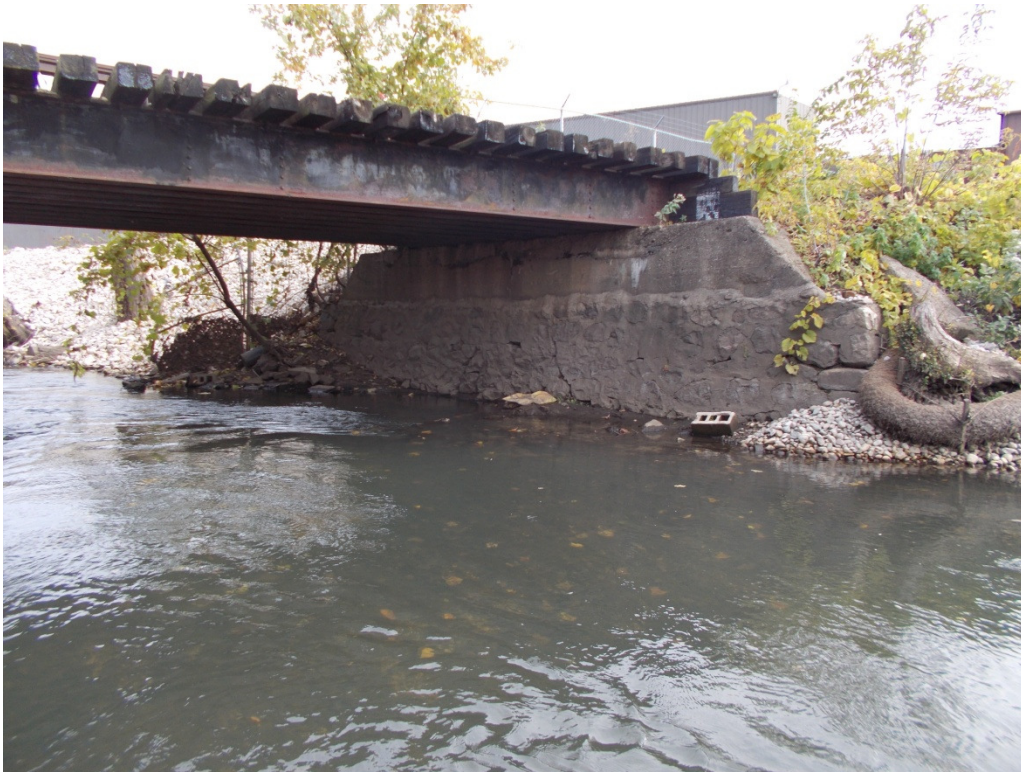
Designation: SA1-C-S08

- Severe deterioration of lower area of west abutment was obscured by high water during Pre-Sediment Removal Structure Assessment. However, the deterioration does not appear to be related to the sediment removal work.
- The structure does not appear to have been impacted during sediment removal.

View of the structure from the southeast

Elevation view looking northeast

View of east abutment looking northeast

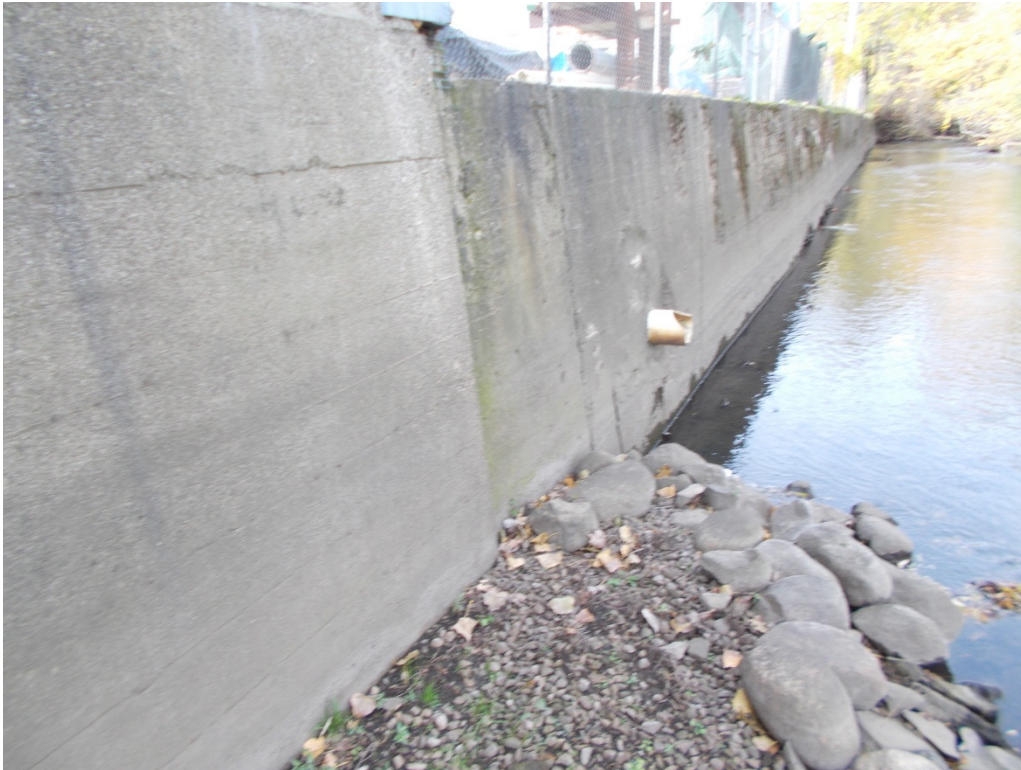
- The structure does not appear to have been impacted during sediment removal.

View of the outlet looking west

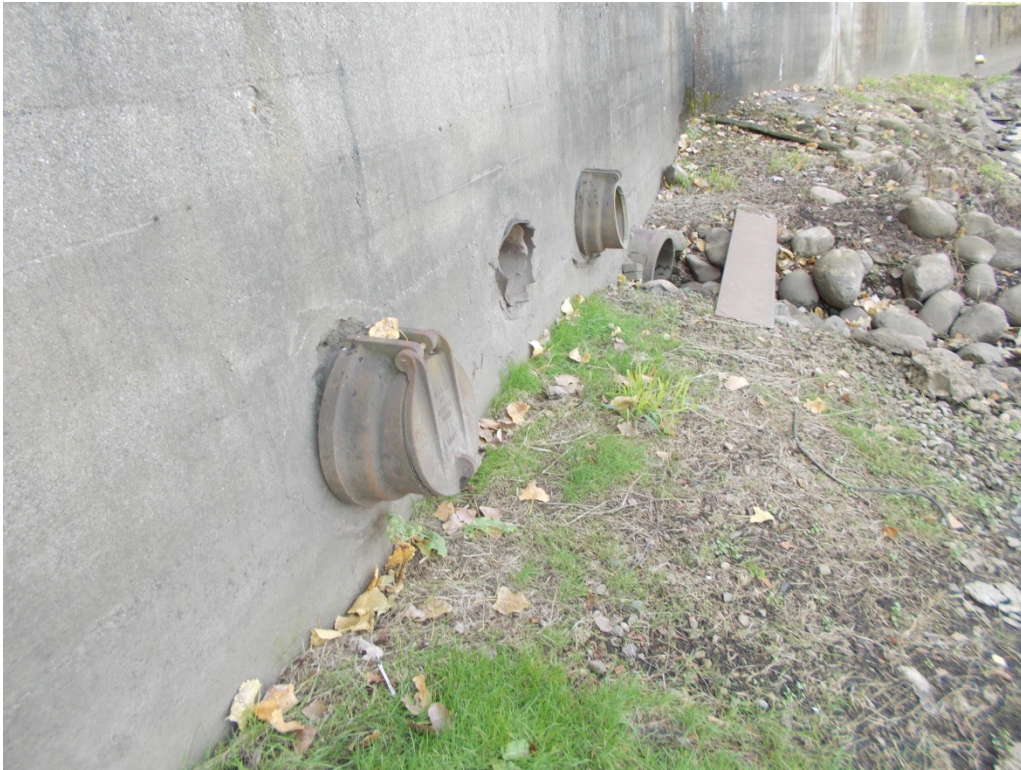
- The structure does not appear to have been impacted during sediment removal.

View of the outlets looking west

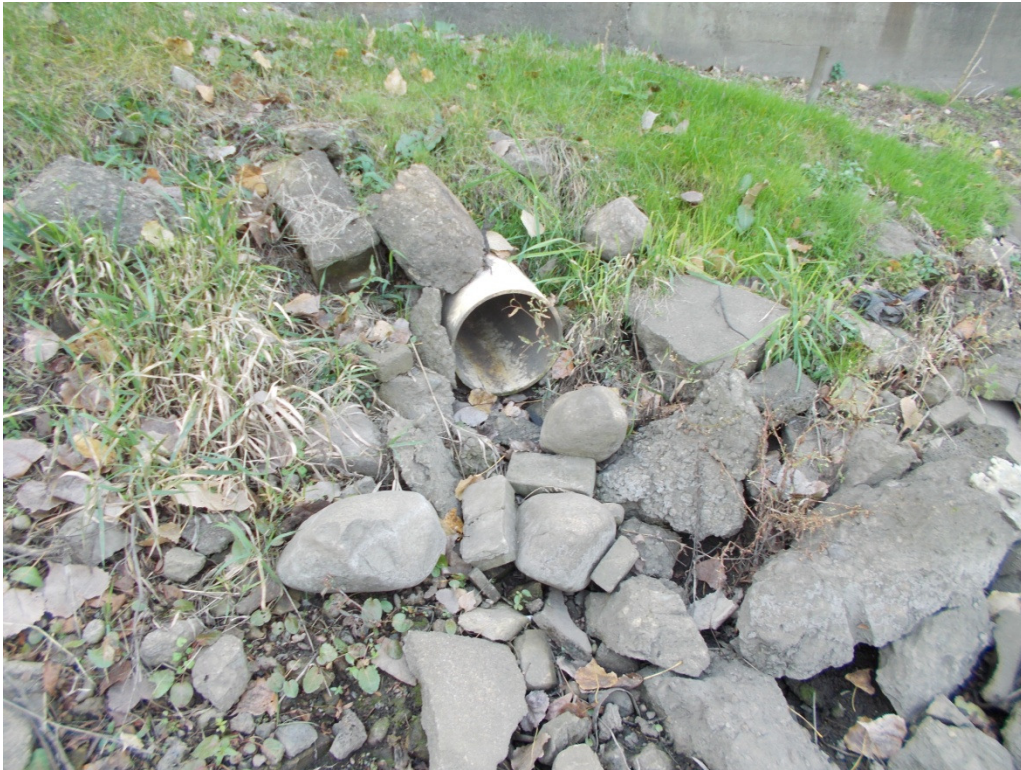
- The structure does not appear to have been impacted during sediment removal.

Close-up view of the structure

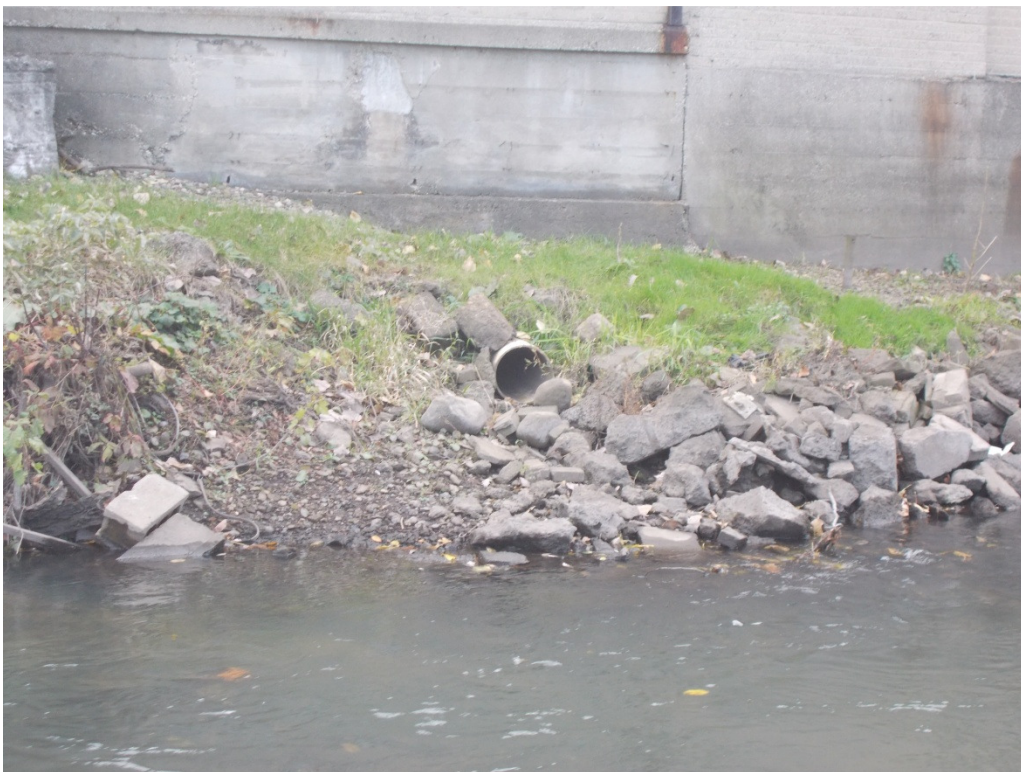
View of the structure looking south

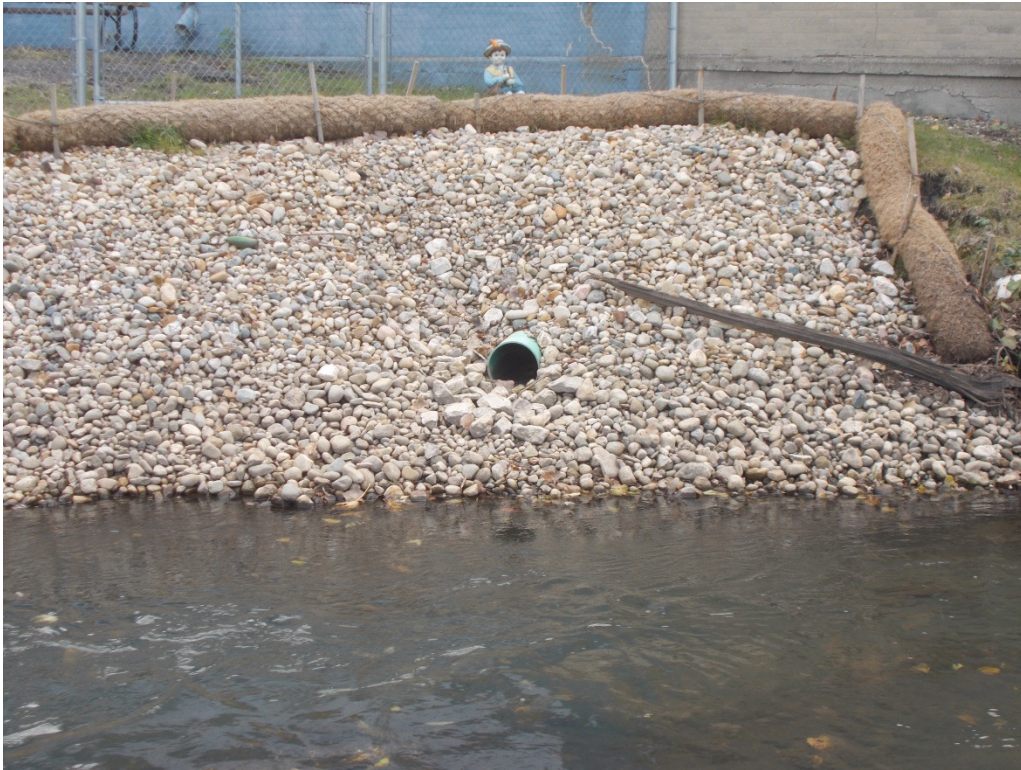
- The structure does not appear to have been impacted during sediment removal.

View of the outlet from the north bank

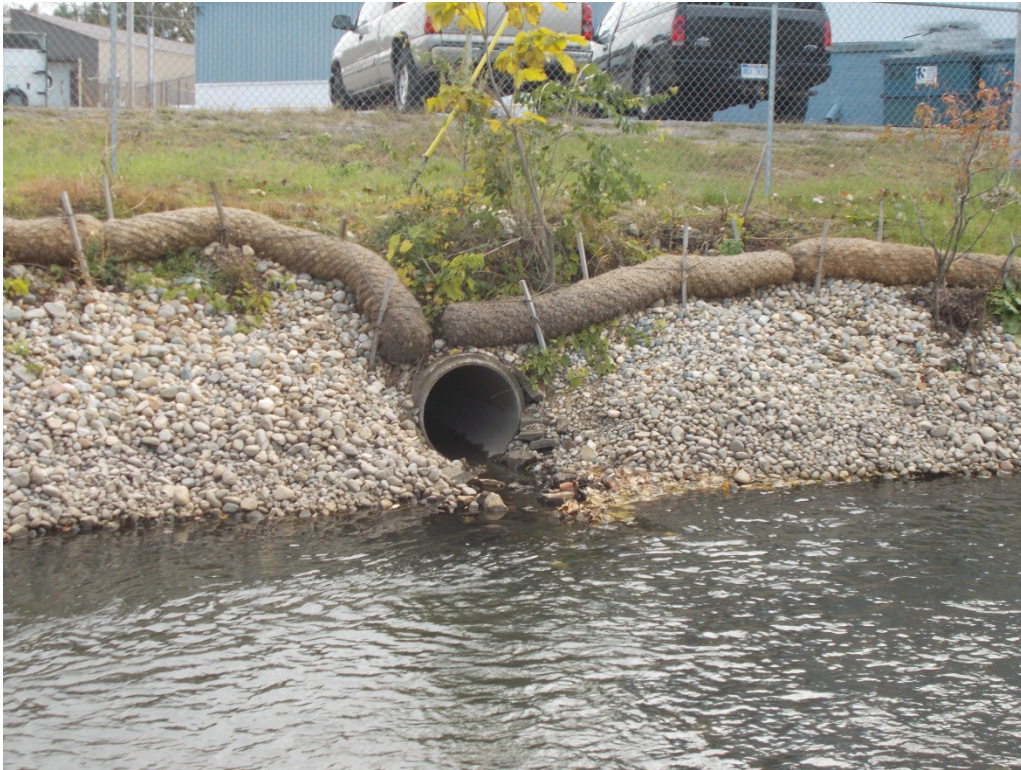
- The structure does not appear to have been impacted during sediment removal.

View of the outlet from the west bank
